**Flood Control Project Maintenance  
Levee Inspections**

## Maintenance Issue Types Only, Levee Inspection Report By Mile - Spring 2017

### Merced Streams Group

Waterway	Bank	Unit Miles	Inspection Start/End	Inspector
Unit No. 01 Black Rascal Diversion	Right	1.61	05/02/2017 05/02/2017	Herman Phillips

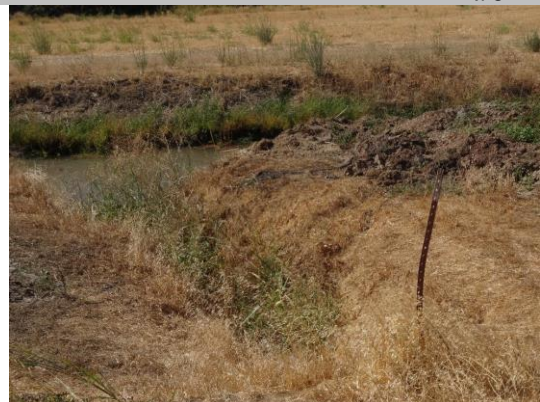
Photo 1 of 3 : UCIP\_SP\_2017\_20946\_35266.jpg

LM Start	0.54	Rating **	M	Issue No.	27
LM End	0.54	Issue Type +	Ma	Location *	WS
Category	Supplemental			GPS Latitude/Longitude	
				Start	End
Item	DWR UCIP LMA Responsibility			37.333180 °	37.333180 °
				-120.394069 °	-120.394069 °
DWR ID					
Comment Code					
Inspector Comment					
FS_ID:20946 DS_ID:23054 EP_NO: N/A Repair Type: Non-Urgent Crossing Status: Found UCIP Comments: - needs vegetation cleaning on both sides.- flap gate was not properly closed during field survey.- inlet needs cleaning. FIELD_STRUCT_DESC: 24-inch corrugated metal drainage pipe through the levee, 12.0 feet below the crown, concrete headwall, flap gate, and concrete grouted cobble spillway on the waterward toe, concrete headwall on the landward toe (O&M Unit No. 607, 1962) FS Date: 9/17/2013

WS view: cobble spillway and channel on waterside.

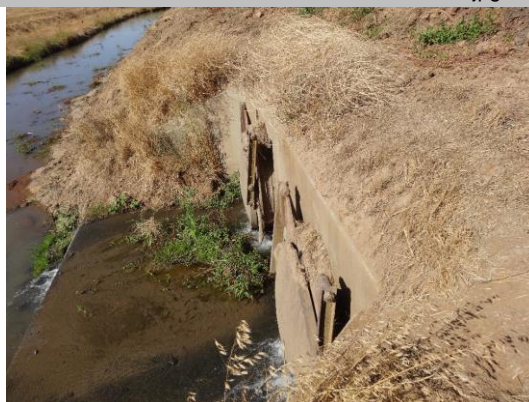
Photo 1 of 3 : UCIP\_SP\_2017\_20965\_35292.jpg

LM Start	0.90	Rating **	A/W	Issue No.	29
LM End	0.90	Issue Type +	Ma	Location *	CR
Category	Supplemental			GPS Latitude/Longitude	
				Start	End
Item	DWR UCIP LMA Responsibility			37.328283 °	37.328283 °
				-120.396074 °	-120.396074 °
DWR ID					
Comment Code					
Inspector Comment					
FS_ID:20965					
DS_ID:23056					
EP_NO: N/A					
Repair Type: No Action Needed					
Crossing Status: Found					
UCIP Comments: - working during field inspection.- vegetation on drainage ditch/channel					
FIELD_STRUCT_DESC: 1 of 2: 60-inch corrugated metal drainage pipe through the levee, 10.0 feet below the crown, concrete headwall and flap gate on the waterward berm, 5 feet from the levee toe, concrete headwall on the landward toe (O&M Unit No. 607, 1962)					
FS Date: 9/17/2013

WS view: two 60" CMPs, flap gates, and headwall on channel bank.

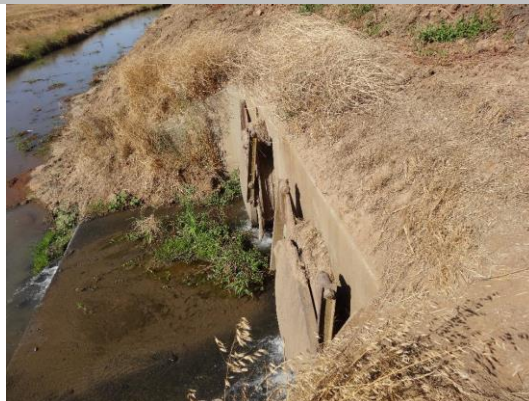
Photo 1 of 3 : UCIP\_SP\_2017\_20983\_35302.jpg

LM Start	0.91	Rating **	A/W	Issue No.	30
LM End	0.91	Issue Type +	Ma	Location *	CR
Category	Supplemental			GPS Latitude/Longitude	
				Start	End
Item	DWR UCIP LMA Responsibility			37.328267 °	37.328267 °
				-120.396084 °	-120.396084 °
DWR ID					
Comment Code					
Inspector Comment					
FS_ID:20983					
DS_ID:23080					
EP_NO: N/A					
Repair Type: No Action Needed					
Crossing Status: Found					
UCIP Comments: It was working during field inspection. Dense vegetation in drainage ditch.					
FIELD_STRUCT_DESC: 2 of 2: 60-inch corrugated metal drainage pipe through the levee, 10.0 feet below the crown, concrete headwall and flap gate on the waterward berm, 5 feet from the levee toe, concrete headwall on the landward toe (O&M Unit No. 607, 1962)					
FS Date: 9/17/2013

WS view: two CMPs with flap gate, concrete spillway and channel on waterside.

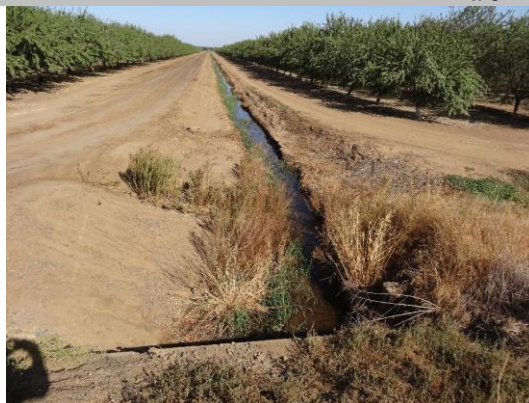
Photo 3 of 3 : UCIP\_SP\_2017\_20984\_35303.jpg

LS view: concrete headwall on levee toe and drainage ditch.

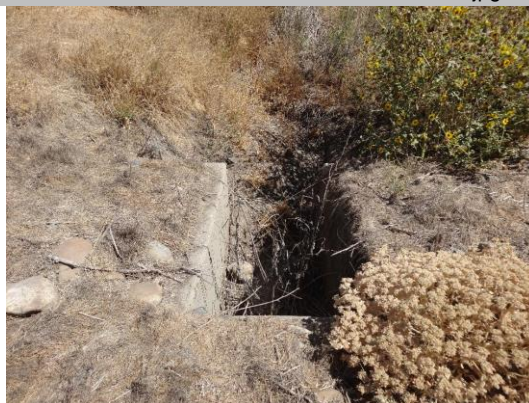
Photo 1 of 3 : UCIP\_SP\_2017\_50144\_35422.jpg

FS\_ID:50144  
DS\_ID:23061  
EP\_NO: N/A  
Repair Type: No Action Needed  
Crossing Status: Found  
UCIP Comments: 09/01/2016: Crossing has been downgraded from Urgent to No Action Needed. (K. Fazel - UCIP)09/01/2016: Not abandoned. LS and WS cleared. Gate swings free. Photos uploaded. (M. Walejko - NA0013)08/23/2016: Same as last inspection. (K. Fazel - UCIP)09/17/2013: Appears to be abandoned. Flapgate blocked by debris.- debris blocked inlet pipe on LS.- Needs to be cleared on both sides or it needs to be abandoned properly. (P. Amatya - UCIP)  
FIELD\_STRUCT\_DESC: 24-inch corrugated metal drainage pipe through the levee, 10 feet below the crown. Concrete headwall, flap gate, and concrete grouted cobble spillway on the waterside (WS) toe. Concrete headwall on the landside (LS) toe [Additional Reference(s): DWR Levee Log, 2005. USACE San Joaquin O&M Manual No. 607, 1962 (HLM 0.4)].  
FS Date: 9/1/2016

WS view: U typed concrete headwall, cobble spillway, and channel on waterside.

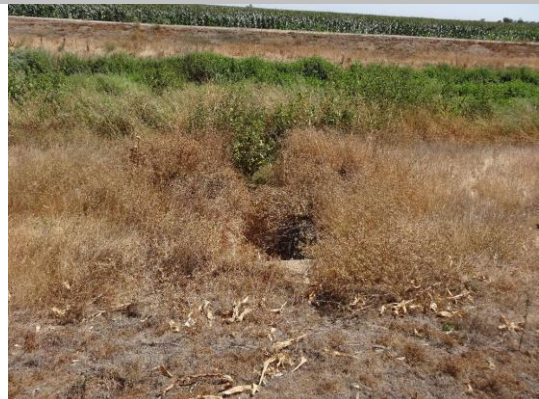
Photo 1 of 3 : UCIP\_SP\_2017\_50151\_35539.jpg

LM Start	0.79	Rating **	A/W	Issue No.	17
LM End	0.79	Issue Type +	Ma	Location *	WS
Category	Supplemental			GPS Latitude/Longitude	
				Start	End
Item	DWR UCIP LMA Responsibility			37.268420 °	37.268420 °
				-120.286231 °	-120.286231 °
DWR ID					
Comment Code					
Inspector Comment					
FS_ID:50151 DS_ID:23063 EP_NO: N/A Repair Type: No Action Needed Crossing Status: Found UCIP Comments: 09/2016: LS and WS ends have been cleared by NA0013 and crossing has been downgraded to No Action Needed. (K. Fazel - UCIP)09/2013: Needs vegetation clearing on WS. (P. Amatya - UCIP) FIELD_STRUCT_DESC: 24-inch corrugated metal drainage pipe through the levee, 6.5 feet below the crown, concrete headwall, flap gate, and concrete grouted cobble spillway on the waterward toe, concrete headwall on the landward toe (O&M Unit No. 607, 1962) FS Date: 9/7/2016

WS view: overview of spillway/outlet area on waterside.

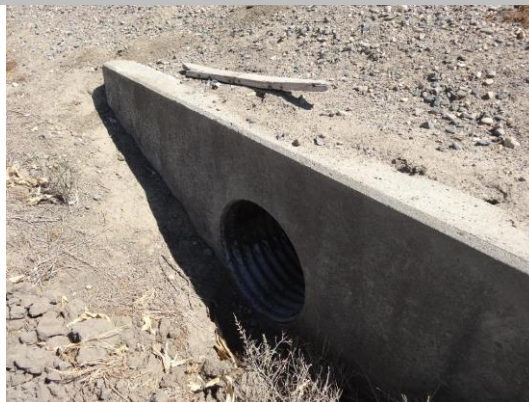
Photo 3 of 3 : UCIP\_SP\_2017\_50151\_35541.jpg

LS view: concrete headwall and CM pipe.

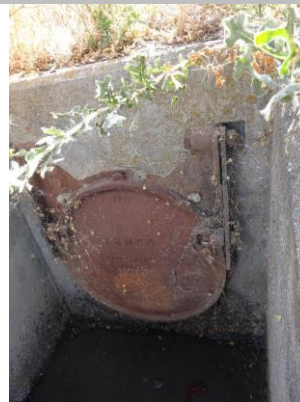
Photo 2 of 3 : UCIP\_SP\_2017\_50148\_35612.jpg

WS view: U typed concrete headwall, CM pipe, and flap gate.

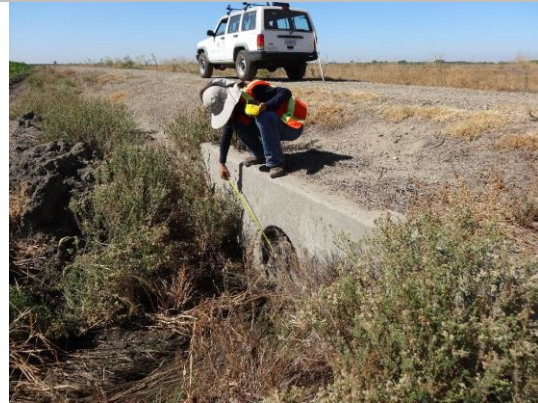
Photo 3 of 3 : UCIP\_SP\_2017\_50148\_35611.jpg

Item	DWR UCIP LMA Responsibility			37.270318 °	37.270318 °	
				-120.284222 °	-120.284222 °	
DWR ID						
Comment Code						
Inspector Comment						
FS_ID:50148						
DS_ID:23071						
EP_NO: N/A						
Repair Type: No Action Needed						
Crossing Status: Found						
UCIP Comments: 09/29/2016: WS headwall, flap gate and spillway have been cleared of vegetation by Mike Walejko of NA0013. Crossing has been downgraded from Non-Urgent to No Action Needed. (K. Fazel - UCIP)09/2013:- vegetations clearing on spillway area. (P. Amatya - UCIP)						
FIELD_STRUCT_DESC: 24-inch corrugated metal drainage pipe through the levee, 5.0 feet below the crown, concrete headwall, flap gate, and concrete grouted cobble spillway on the waterward toe, concrete headwall on the landward toe (O&M Unit No. 607, 1962)						
FS Date: 9/7/2016

LS view: concrete headwall and CM pipe.

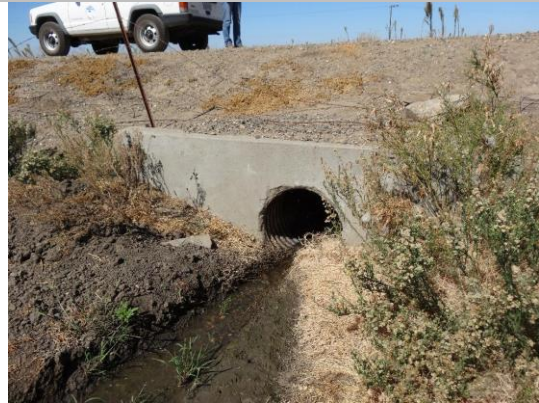
Photo 3 of 3 : UCIP\_SP\_2017\_21126\_35654.jpg

LM Start	0.81	Rating **	M	Issue No.	19 (cont)	
LM End	0.81	Issue Type +	Ma	Location *	LS	
Category	Supplemental			GPS Latitude/Longitude		
				Start	End	
Item	DWR UCIP LMA Responsibility			37.265948 °	37.265948 °	
				-120.287790 °	-120.287790 °	
DWR ID						
Comment Code						
Inspector Comment						
FS_ID:21126						
DS_ID:23073						
EP_NO: N/A						
Repair Type: Non-Urgent						
Crossing Status: Found						
UCIP Comments: - needs vegetation clearing on waterside.- concrete spillway on waterside.- the drainage was working during field survey.						
FIELD_STRUCT_DESC: 24-inch corrugated metal drainage pipe through the levee, 6.0 feet below the crown, concrete headwall, flap gate, and concrete grouted cobble spillway on the waterward toe, concrete headwall on the landward toe (O&M Unit No. 607, 1962						
FS Date: 9/17/2013

LS view: concrete headwall and CM pipe. Drain pipe was working during field survey.

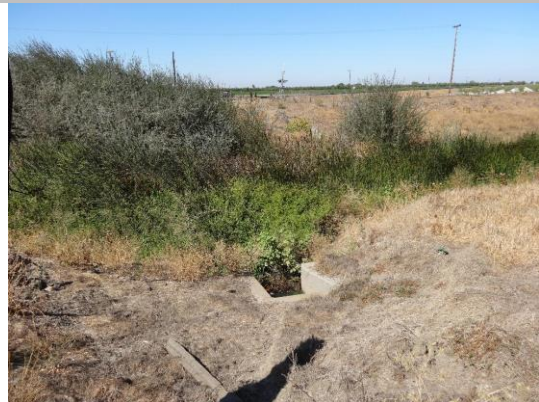
Photo 1 of 3 : UCIP\_SP\_2017\_21127\_35657.jpg

LM Start	1.01	Rating **	A/W	Issue No.	20
LM End	1.01	Issue Type +	Ma	Location *	LS
Category	Supplemental			GPS Latitude/Longitude	
				Start	End
Item	DWR UCIP LMA Responsibility			37.263139 °	37.263139 °
				-120.287799 °	-120.287799 °
DWR ID					
Comment Code					
Inspector Comment					
FS_ID:21127					
DS_ID:23074					
EP_NO: N/A					
Repair Type: No Action Needed					
Crossing Status: Found					
UCIP Comments: - concrete spillway on waterside.- drainage was working during field survey.					
FIELD_STRUCT_DESC: 24-inch corrugated metal drainage pipe through the levee, 8.0 feet below the crown, concrete headwall, flap gate, and concrete grouted cobble spillway on the waterward toe, concrete headwall on the landward toe (O&M Unit No. 607, 1962)					
FS Date: 9/17/2013

WS view: U typed concrete headwall and channel on waterside.

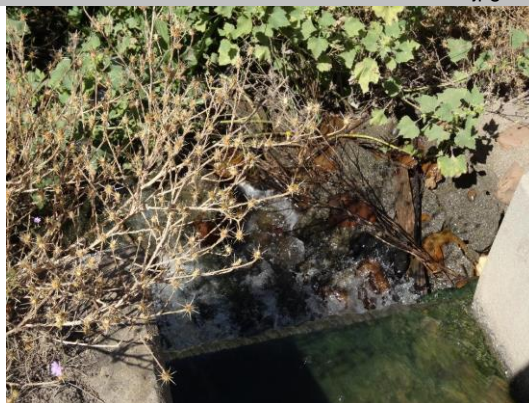
Photo 2 of 3 : UCIP\_SP\_2017\_21127\_35656.jpg

WS view: concrete headwall and concrete spillway on waterside.

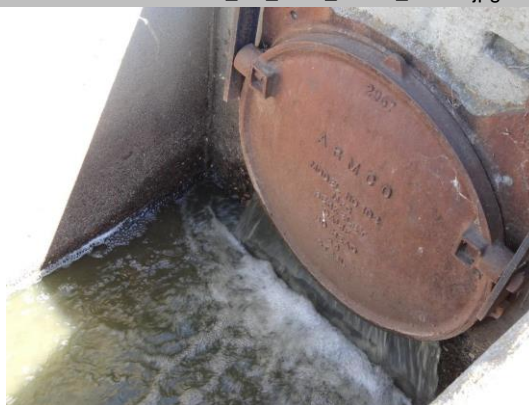
Photo 3 of 3 : UCIP\_SP\_2017\_21127\_35655.jpg

WS view: U typed concrete headwall, CM pipe, and flap gate. Drainage was working during survey.
